THE *NORWAY* BOILER EXPLOSION

At 0637 on May 25th, 2003, the passenger vessel Norway (formerly France), suffered a boiler rupture in the aft boiler room about an hour after the vessel had moored in Miami, Florida, at the end of a seven-day Caribbean cruise. Eight crewmembers sustained fatal injuries, 10 suffered serious injuries, and seven received minor injuries. No passengers were injured

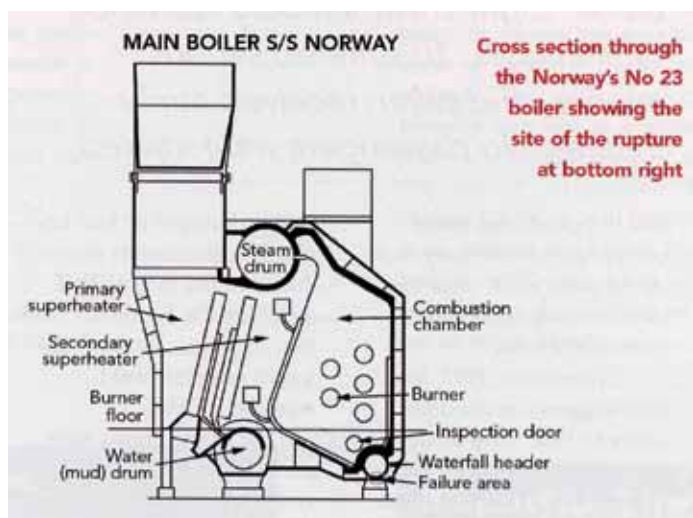
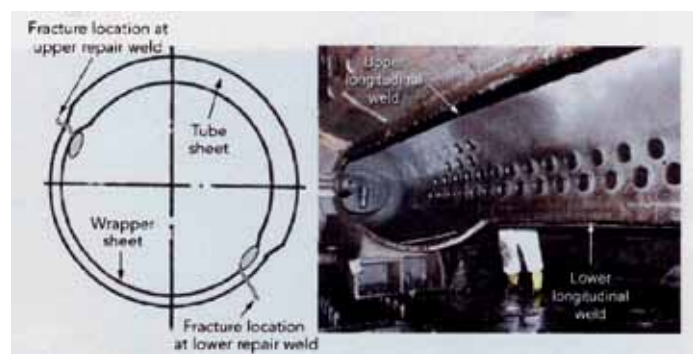
Schematic (left) showing location of fracturing along the longitudinal welds, and partial view (right) of damaged waterfall header, looking aft. The waterfall header was constructed by longitudinally welding together two half-cylinders and then welding caps (dished heads) on either end. The two half-cylinders were of different thicknesses. During the manufacture of the header, the tube sheet was tapered down to the wrapper sheet and the two were welded together at the bottom of the tapered region. The header fractured where weld repairs had been made along the original longitudinal welds joining the tube sheet and the wrapper sheet

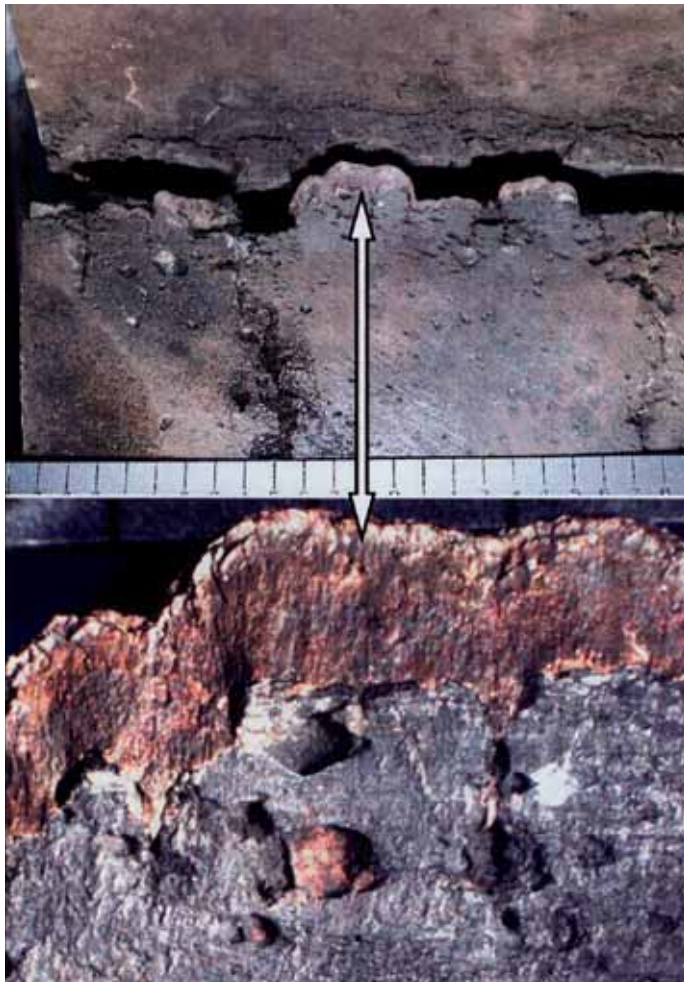
View of matching fracture halves (above) and enlarged image of copper nuggets (below) at the edge of the fracture. Arrow points to area of enlarged image. It appears that copper tubing may have been deliberately introduced into the boiler waterwall header during a misguided maintenance action

- Lack of adherence to water chemistry composition limits and procedures by both the water chemistry subcontractors and NCL during wet lay-up periods, leading to pitting from oxygen corrosion
- Failure to take number of boiler cycles into account during maintenance
- Severe thermal transients from heating and cooling the boilers too quickly and from constraints created by frozen boiler support feet
- Use of questionable weld repair procedures
- Lack of appropriate non-destructive testing by the BV surveyors and NCL inspectors to determine whether cracks were present
- Inadequate survey guidance from BV to its surveyors
- Failure to repair cracks into which copper had been inappropriately introduced.
