Proper Design And Analysis Of High-Speed Engine Exhaust Systems Improve Safety And Reliability > GCC provides insight into best design practices

BY NORM SHADE

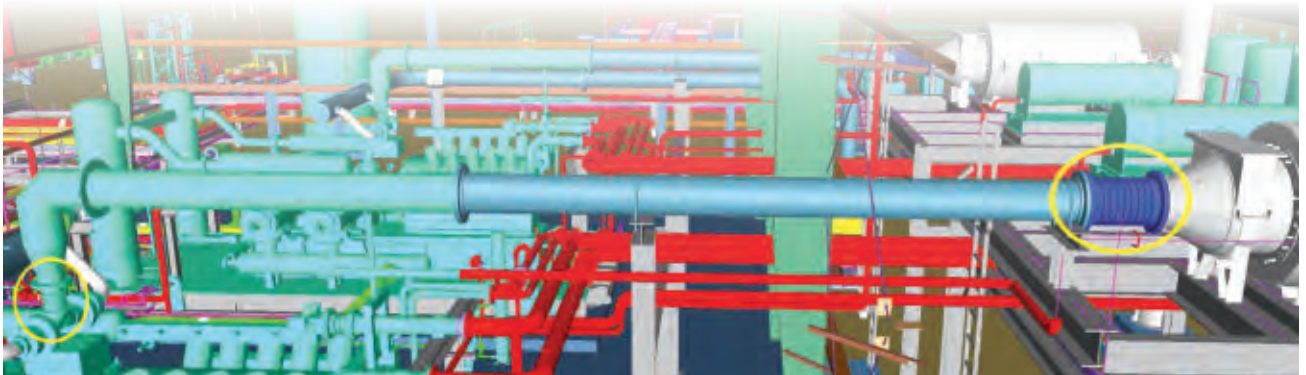
■ As originally designed, the exhaust systems on the engines depicted in this CAD model experienced failures of the vertical expansion joint connected to the engine turbocharger exhaust and to the horizontal expansion joint connected to the exhaust catalyst outside the building wall.

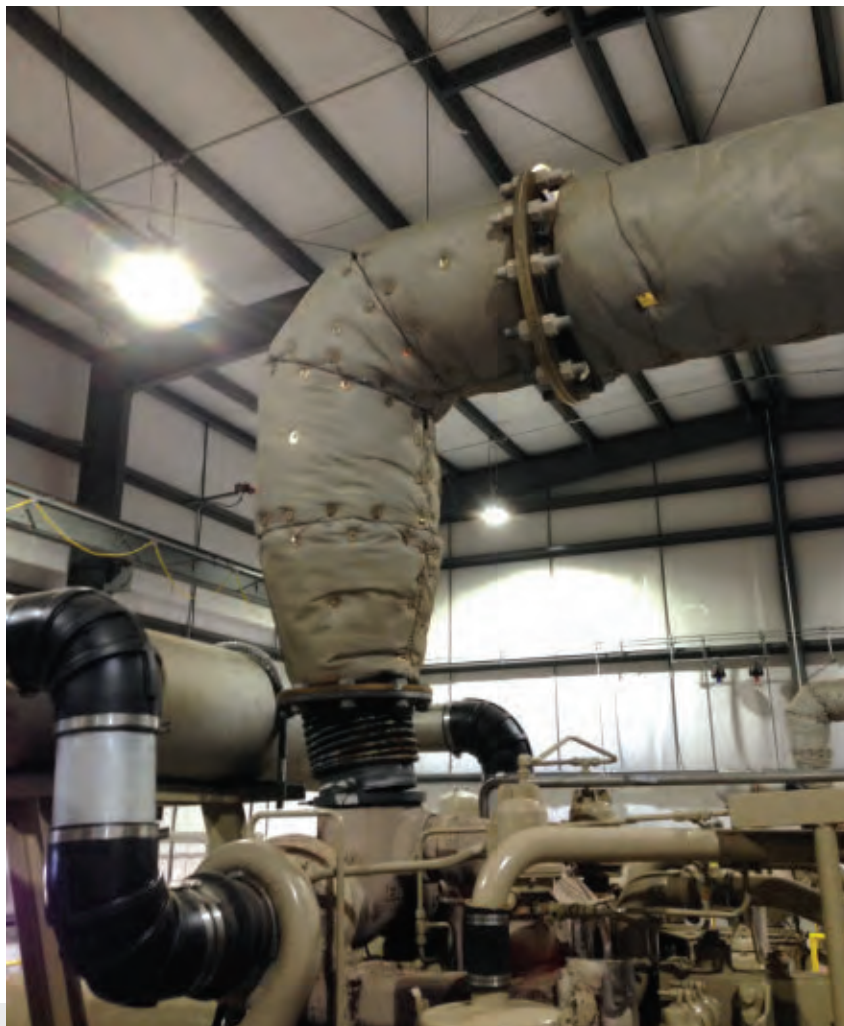
The analysis revealed that the expansion joint failures resulted from thermal expansion forces in the horizontal plane of the vertically mounted

■ The failure of this expansion joint (left) located at the engine turbocharger exhaust flange resulted from inadequate support and excessive thermal growth of the long exhaust line (right) running from the engine to the catalyst outside the building wall.

expansion joint. With the engine running at full temperature, with the original support system, the analysis predicted a lateral force of 2298 lb. (1042 kg) acting on the first expansion joint. The engine manufacturer's specifications indicated that the expansion joint was designed for axial load with a deflection limit of 0.23 in. (5.84 mm), but not designed to tolerate any lateral load, having a lateral deflection limit of only 0.07 in. (1.8 mm).

From the analysis results, it was concluded that both expansion joint failures were occurring because the horizontal expansion joint at the catalytic converter was improperly sized. The thermal expansion was fully compressing the custom expansion joint

and the remaining thermal expansion was propagating back to the vertical expansion joint at the engine, which was not designed to handle horizontal forces or movement.

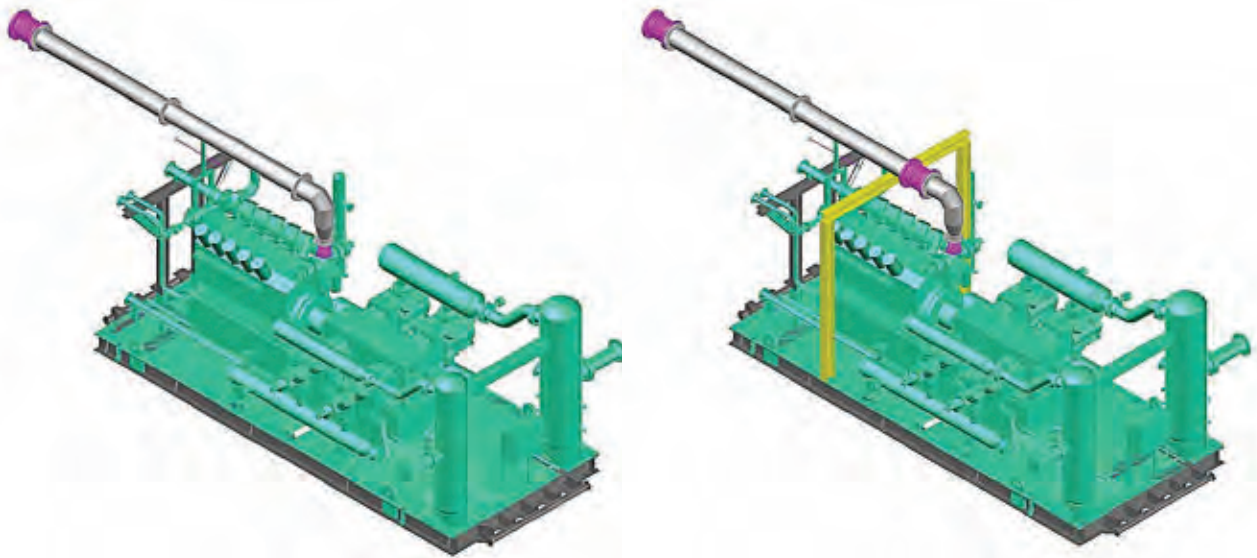
■ After looking at many options to improve the reliability of the original exhaust system (left), GCC's solution (right) was to replace the expansion joint at the catalytic converter, add an additional expansion joint in the horizontal axis of the exhaust system right after the 90° bend from the vertical section of pipe, and add a support to fix the vertical section of pipe horizontally, eliminating horizontal forces on the vertically mounted expansion joint.

After multiple design iterations intended at eliminating the horizontal forces and subsequent movement in the vertical expansion joint at the engine, GCC's proposed solution was to replace the expansion joint at the catalytic converter, add an additional expansion joint in the horizontal axis of the exhaust system right after the 90° bend from the vertical section of pipe, and add a support that fixed the vertical section of pipe horizontally, so that no horizontal forces could act upon the vertically mounted expansion joint. This proposed arrangement eliminated all the excess forces in the

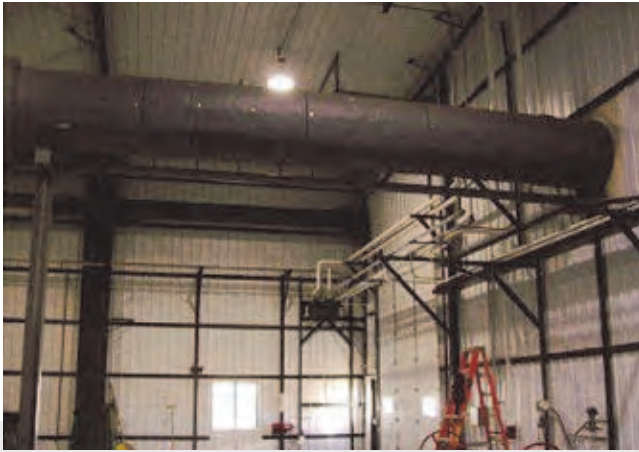
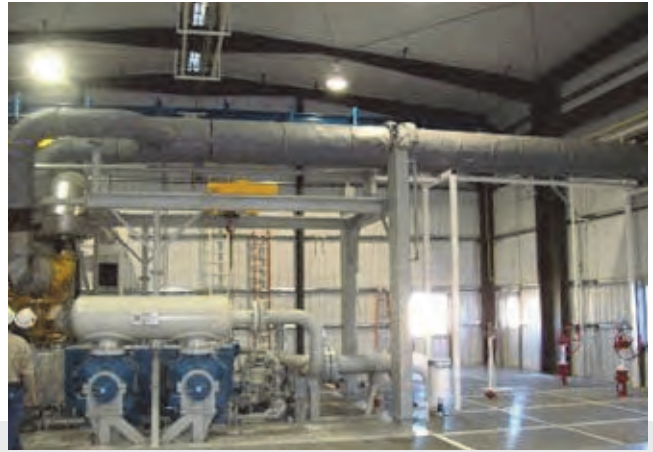
A different example of problems involving an improperly designed exhaust system had even more severe implications. In this case, a long, improperly supported exhaust line was originally supported by part of the building wall structure. The thermal growth of the long exhaust pipe span caused the building wall to deflect outward. In addition, vibration in the pipe excited the wall so that it also vibrated, creating noise and a risk of structural failure of the building itself. Left uncorrected, the vibration could have damaged electrical conduit, lights and other items, caused false shutdowns, and even destroyed the entire building wall in the worst case. The problem was resolved by adding a goal post structure to properly support the heavy exhaust line before it went through the building wall. Welding the goal post frame to the wall also stiffened the wall and eliminated the noise and vibration.

■ Where it exits the building at upper left, this large engine exhaust pipe was originally supported directly on the building wall (left). This arrangement caused vibration of the wall that raised the noise level and likely would have led to structural failure of the building. Bracing and structural support were added in the form of a large goal post, partially visible near the wall (right), which is welded to the building structure, making the wall much stiffer while also supporting the weight of the exhaust line.
