CUTTING the COST of CAVITATION

CAVITATION DAMAGE CAN RENDER EQUIPMENT USELESS IF LEFT UNTREATED, SO HERE WE LOOK AT NEW METHODS TO COMBAT THE PROBLEM

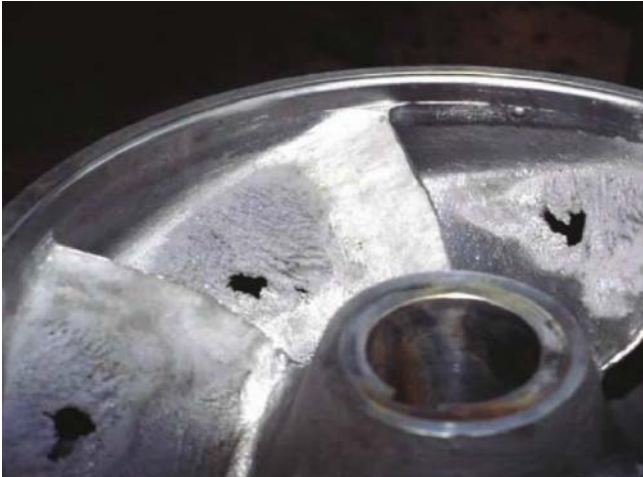
Figure 2 - Cavitation Damage in Identical Areas

Cavitation damage can render equipment useless if left untreated. Pumps tend to show accelerated rates of cavitation due to the high rate of fluid flow across the blades. The damage resembles a substrate that has been shot blasted in one place until holes appear. There will always be varying amounts of damage depending on fluid velocity and substrate material.

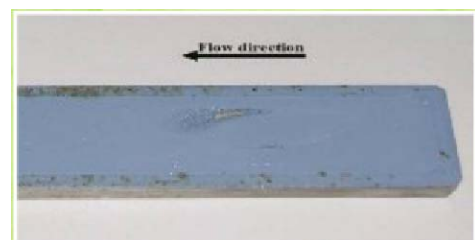
Figure 3 - Belzona 1341 after erosion testing

The independent testing comprised of a 500 hour erosion simulation where the products were subjected to cavitation effects. As can be seen in figures 3 and 4, the Belzona 1341 had slight damage showing in one particular area. In the same area on the Belzona 2141 there is a very slight shadow but no damage. This damage is from the effects of cavitation and proves the capabilities of a polyurethane coating.

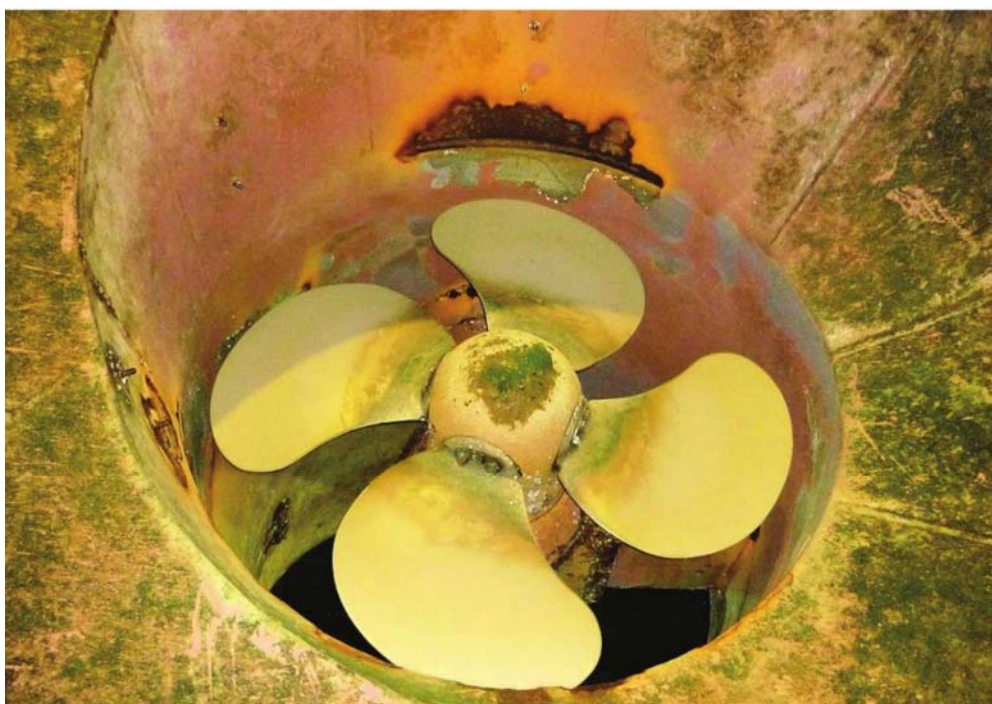
The thruster in its drydocking condition

Deep localised corrosion was found around the stainless steel wear ring of the bow thrusters on a

2500 TEU container vessel during its 10-year drydocking.

The typical damage pattern includes localised but very deep crevices close to the stainless steel ring, with a depth of material loss of up to 95% of the wall thickness being common. The welded seams connecting the stainless steel ring to the hull are particularly affected.

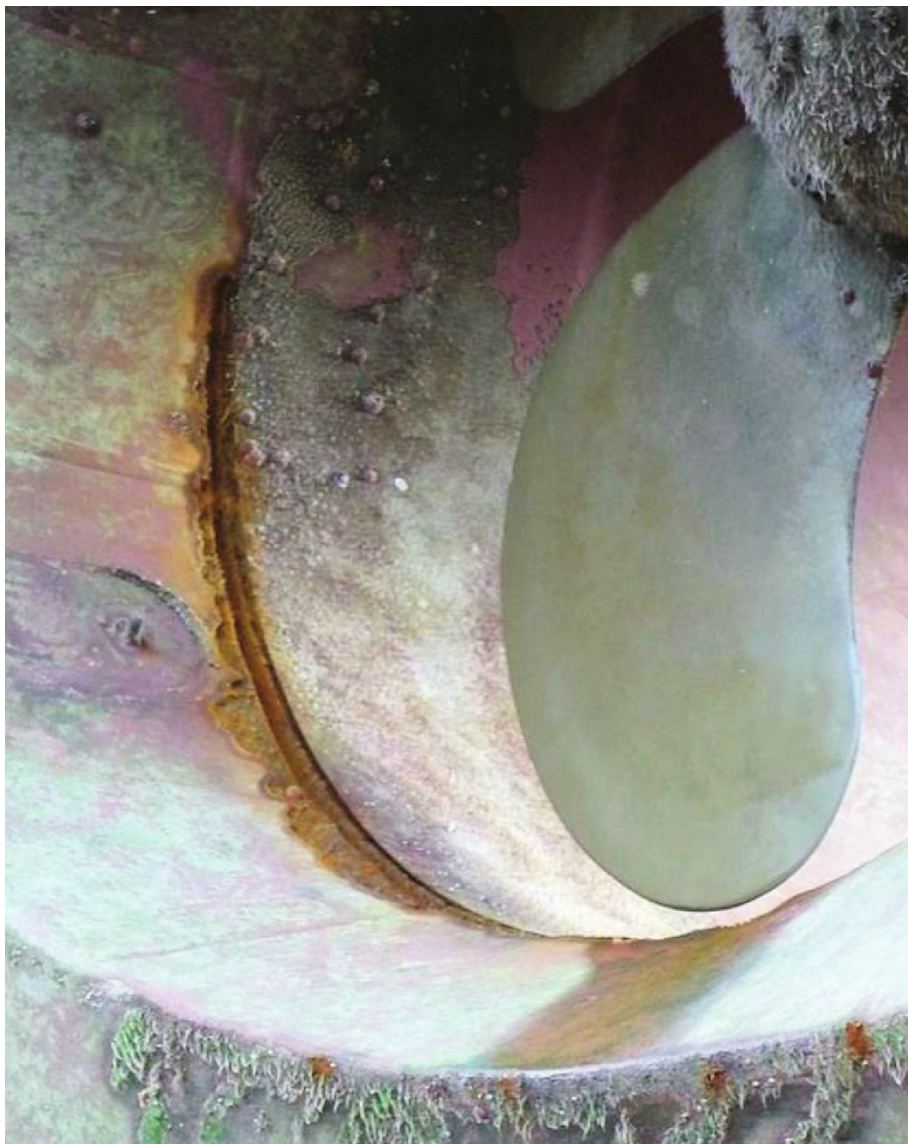
Deep localised corrosion was found around the stainless steel wearing requiring that it be re-welded

The steel structure was reinstated by welding and grinding to classification society standards.

Due to the crevice layout, deep local welding was necessary with multiple bead welding. The welding was followed by dry blasting the surface to SA2 standard to create a good surface profile. After the blasting inspection, the surface was cleaned and coated with Metaline 924. Due to the very uneven welding bead surface, a stripe coating was applied initially in the welding area. Roughly six hours after primer application, the base coat Metaline 900 was applied, preparing for the final elastomer application.

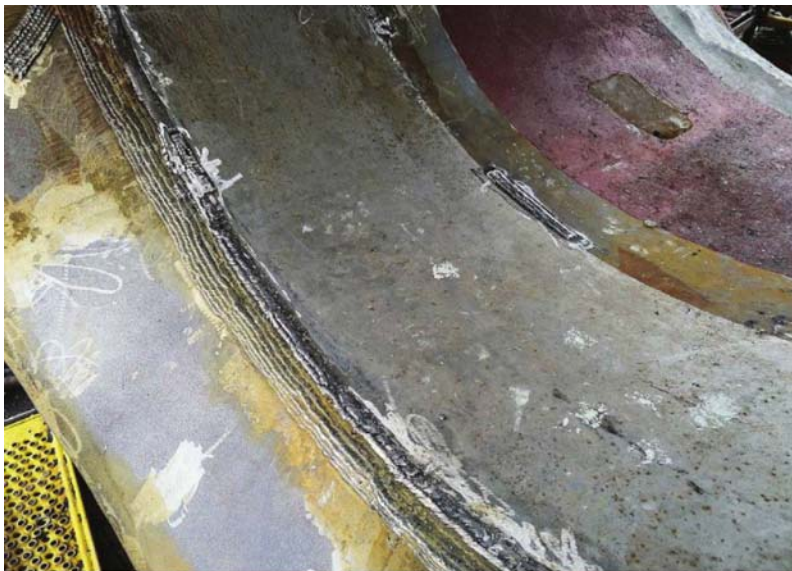
ECOSHIELD RUDDER APPLICATION

In August, several rudders were coated with Hydrex's Ecoshield in China and the US. In China, the rudders of a 261 and a 209m container ship were coated in Guangzhou and Changxing Island, while a 228m vehicle carrier had its rudder coated in Zhoushan. Around the same time Ecoshield was applied on both the rudders of a 46m tug in Mobile, Alabama.

Cavitation erosion damage had appeared on the rudders of these vessels, so the owners had decided to use Ecoshield in order to prevent similar damage from occurring again.

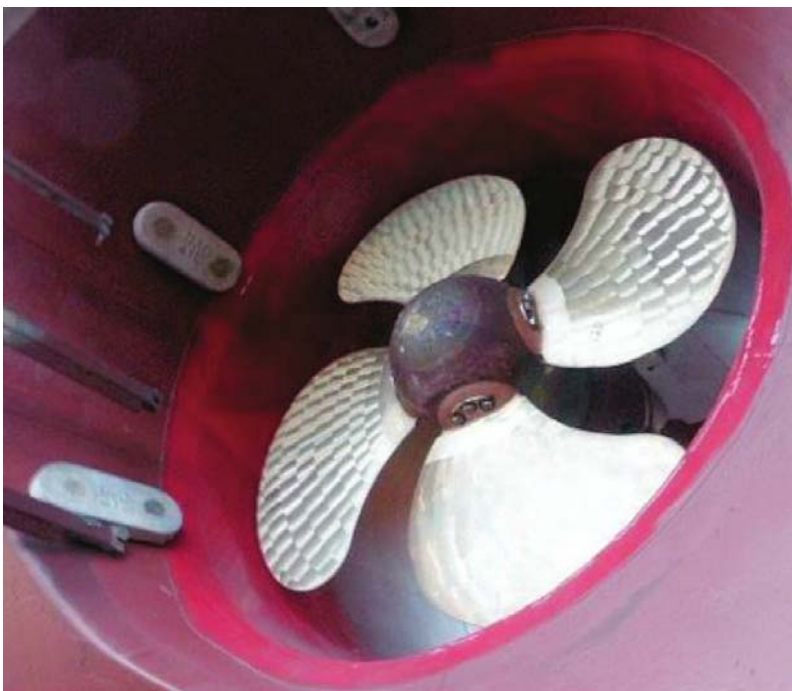
The thruster after welding, (top) the covered welding area, (center) the coating cross section; the final result

Following a 1hr curing time of the base coat, the application of Metaline 785 was started using a simple, yet effective, air driven application gun, as it is delivered ready for use in oneway 1kg cartridges. Due to the over coating time of one to two minutes, a constant application process can be maintained, resulting in a technically sound and very eye-pleasing

The application was done using two different colours. The final coat was applied in red at the request of the owner, while the main thickness was generated in a green colour. In case of extensive wear at any given location, the red top layer may be worn away exposing the green underlying material. This will give a clear and easy indication of wear hot spots which can be immediately identified by divers, even in very poor visibility.
